**Flood Control, Mississippi River and Tributaries
Yazoo River Basin - Tallahatchie River
Tallahatchie County, Mississippi**

**Ascalmore Creek - Tippo Bayou
Item No. 3, Control Structure**

**FOUNDATION
REPORT**

January 1992

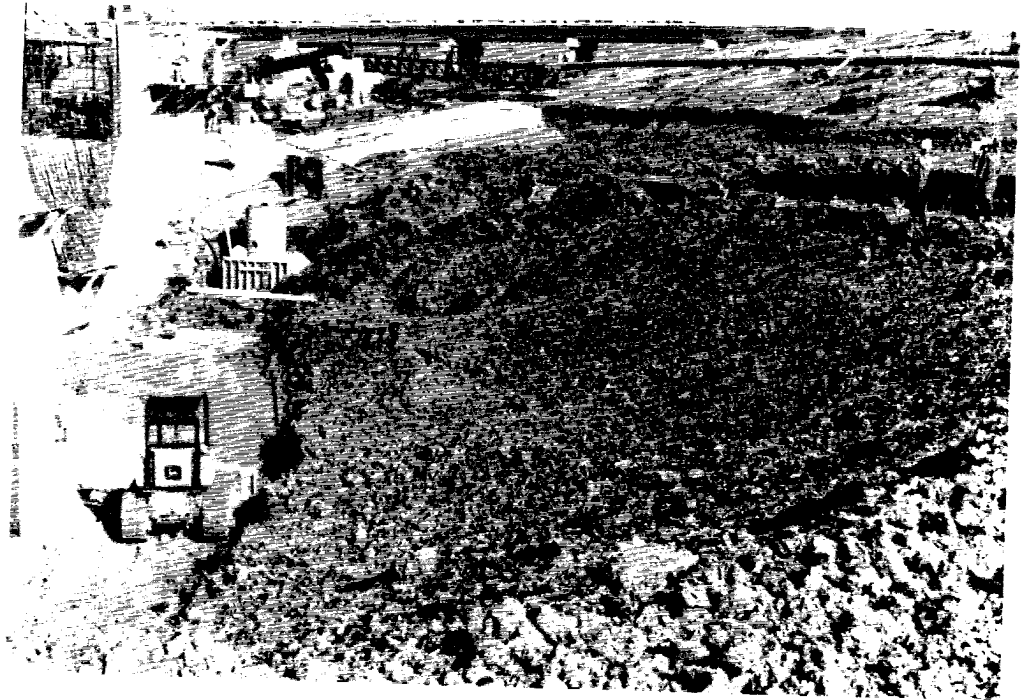
23. RANDOM BACKFILL SLIDE-NOTE ABSENCE OF PERVIOUS BACKFILL

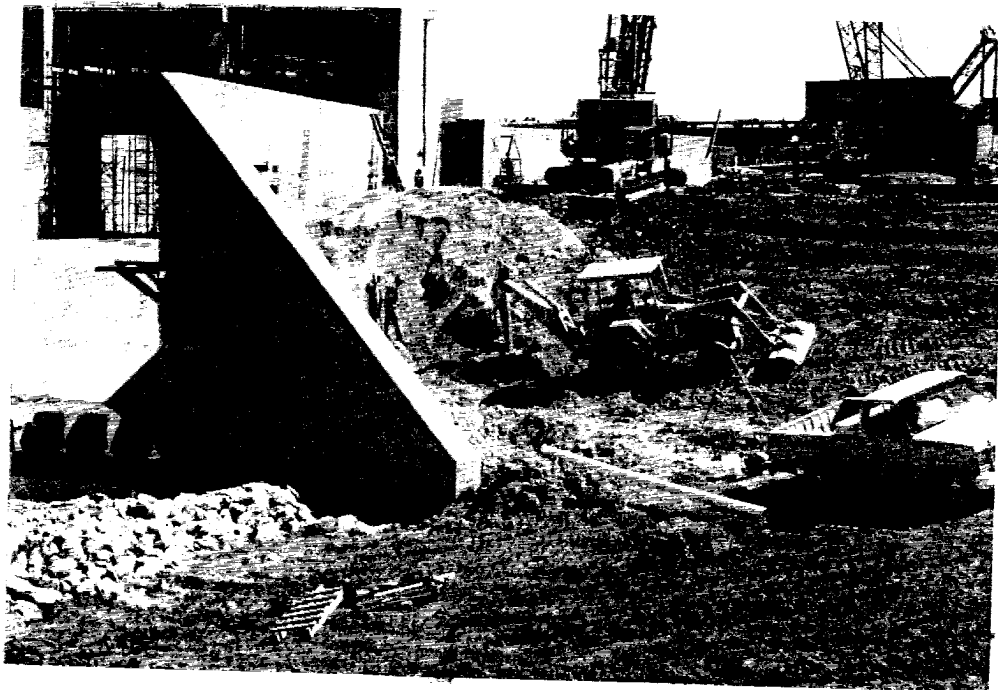
24. INSTALLATION OF COLLECTOR SYSTEM SOUTH RETAINING WALL

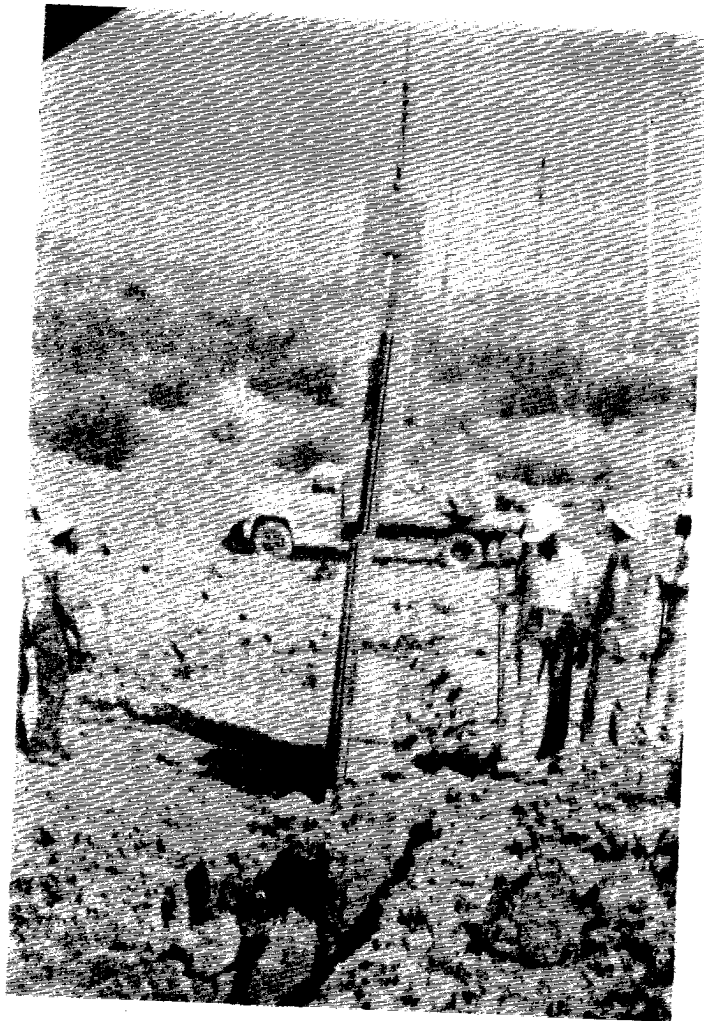
25. INSTALLATION OF SHEET PILE CUTOFF

7-01. Cutoffs. Sheet pile cutoffs to prevent loss of foundation materials were installed beneath all major components of the control structure. For a plan showing the location and details of the sheet pile cutoffs, see Plates 20 and 21, and Photograph 25.
